PTPD REPORT NO. 83-R-02
AFPEA PROJECT NO. 82-P7-68

TEST AND EVALUATION OF METHOD II, GAU-8 30mm
AMMUNITION CONTAINERS

HQ AFALD/PTPD
AIR FORCE PACKAGING EVALUATION AGENCY
Wright-Patterson AFB OH 45433

August 1983

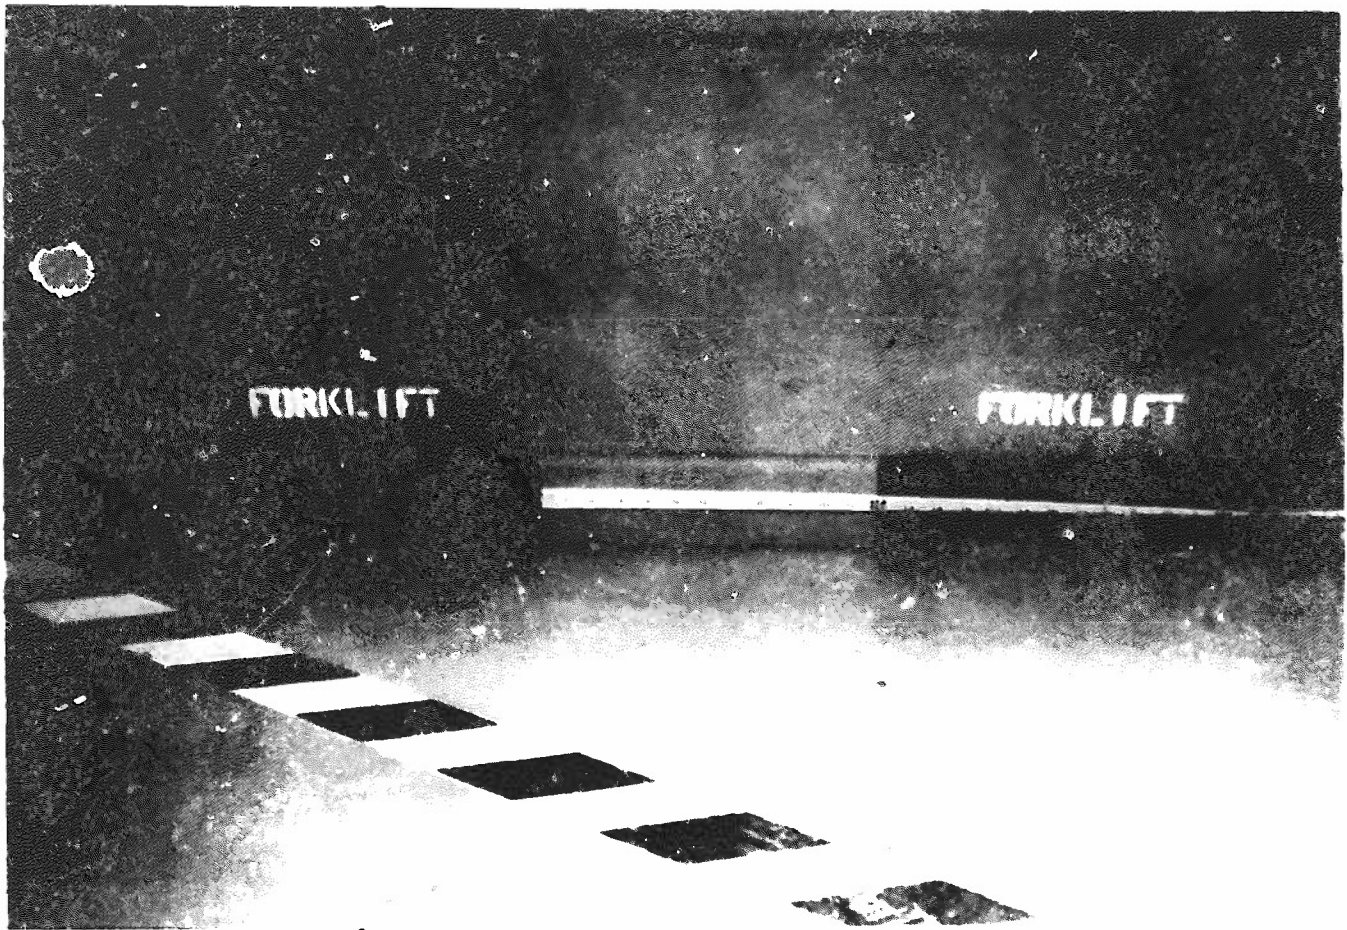
Six Method II, GAU-8 30mm ammunition containers were received on 23 Dec 82. Upon initial inspection, it was determined that these containers did not meet the specification requirements for hand-lift-truck compatibility, 8 1/2" between forklift openings (see Figure 3). They were returned to the manufacturer for modification on 4 Jan 83. The modification consisted of enlarging the forklift openings and strengthening the forkwell area. The modified containers were returned on 6 Jan 83. Containers S/N00005 and 00006 were selected as the test unit and were loaded with dummy ammunition (see Figures 4 & 5). The gross weight of the test unit was 2175 pounds. Testing began on 10 Jan 83 using the following sequence.

FIGURE 3. Original containers did not meet the 8 1/2 inch spacing requirement between forklift openings for the hand-lift-truck compatibility.

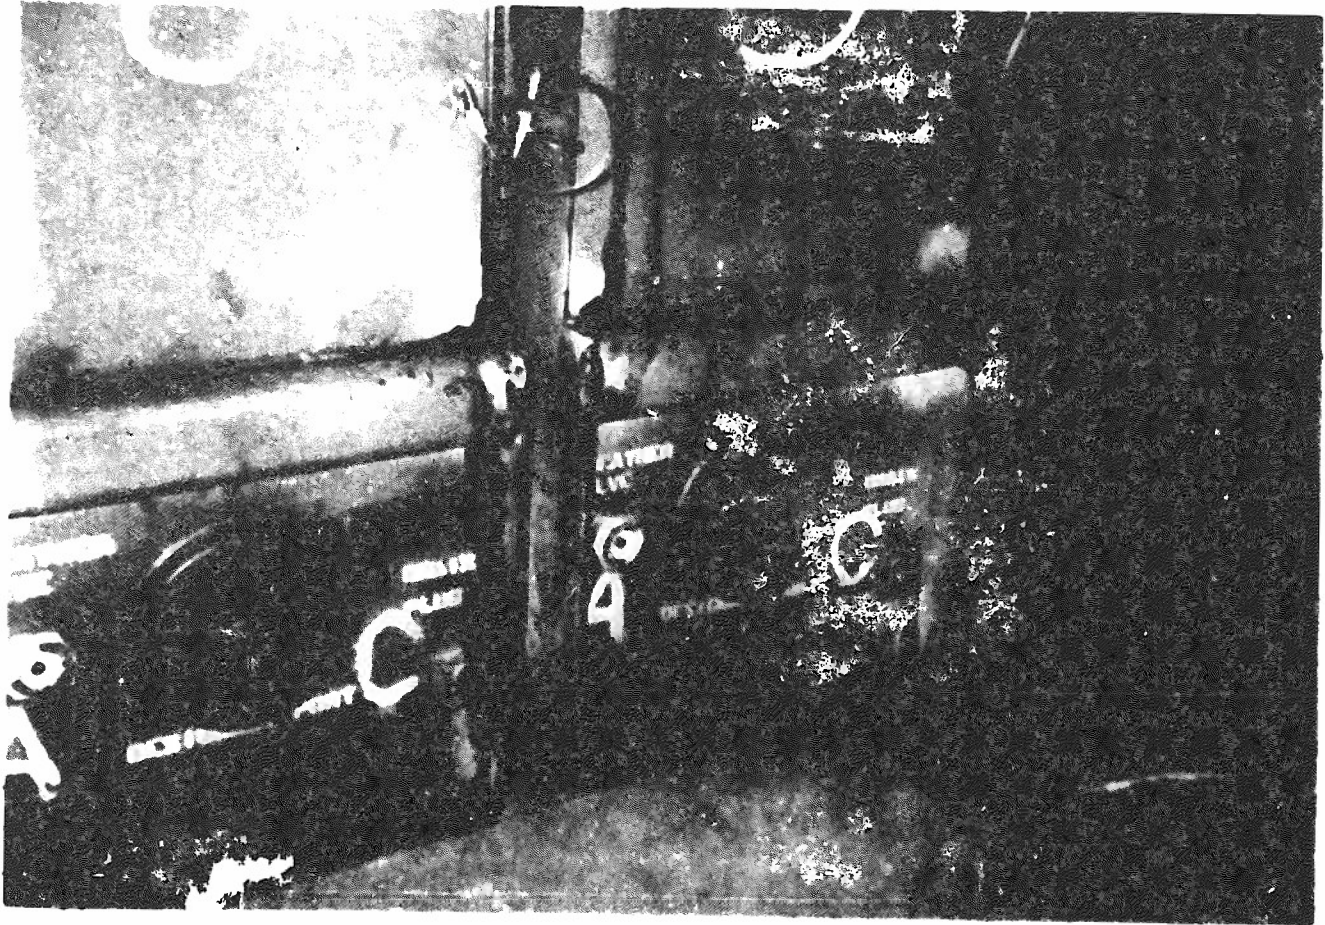
c. Comments: This test was performed out of the proposed test sequence at the manufacturer's request. Obvious deficiencies in the guard for the desiccant port cover and the breather valve existed. The manufacturer's representative had the necessary additional hardware to correct this problem with him but insisted on running the test prior to this modification. When the containers were impacted on the desiccant port ends, the desiccant port caps were crushed and would no longer seal. Also, on the final impact, which was to the broad side of one of the containers in the unit, small tears occurred in the sides of each container where the middle locking angle was welded. The locking pins were located in these middle locking angles. At this time, testing was terminated.

FIGURE 6. Modification made to the containers after failing first Pendulum-Impact Test. Note the steel gussets welded to the impact area of the containers.

The containers comprising the test unit were disassembled, repaired and modified by welding two steel gussets to the containers as indicated in Figure 6. The same two containers were used again as the test unit except that their locking pin locations were changed to the top and bottom locking angles (see Figure 7). The relative position of each container was changed so that the same sides would not be impacted during the following tests. Testing was restarted on Tuesday, 11 Jan 83, and this time the initially proposed test sequence was followed:

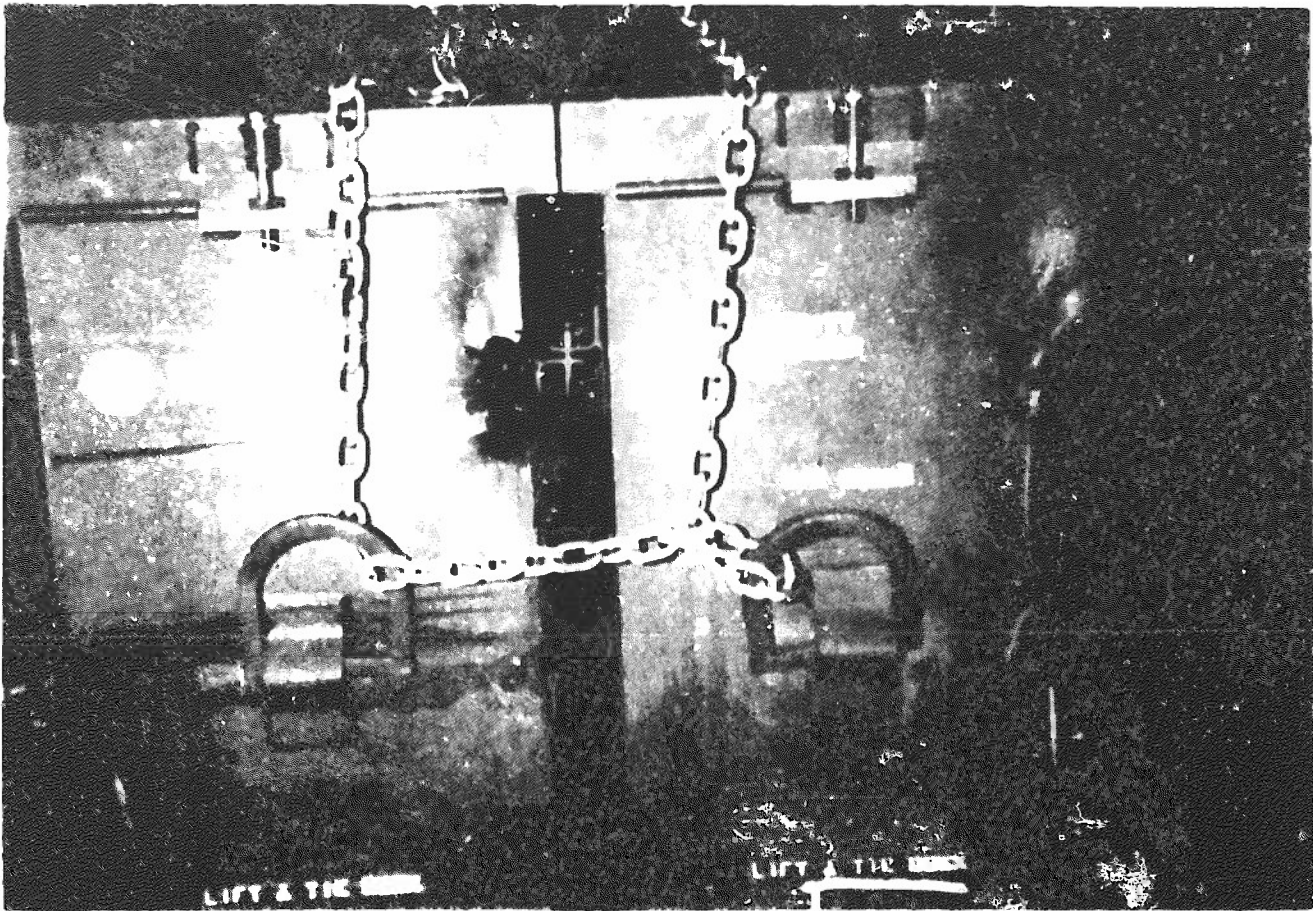
FIGURE 7. The position of the connecting pins was changed from the middle locking angle to the top locking angle due to failure during the first Pendulum-Impact Test.

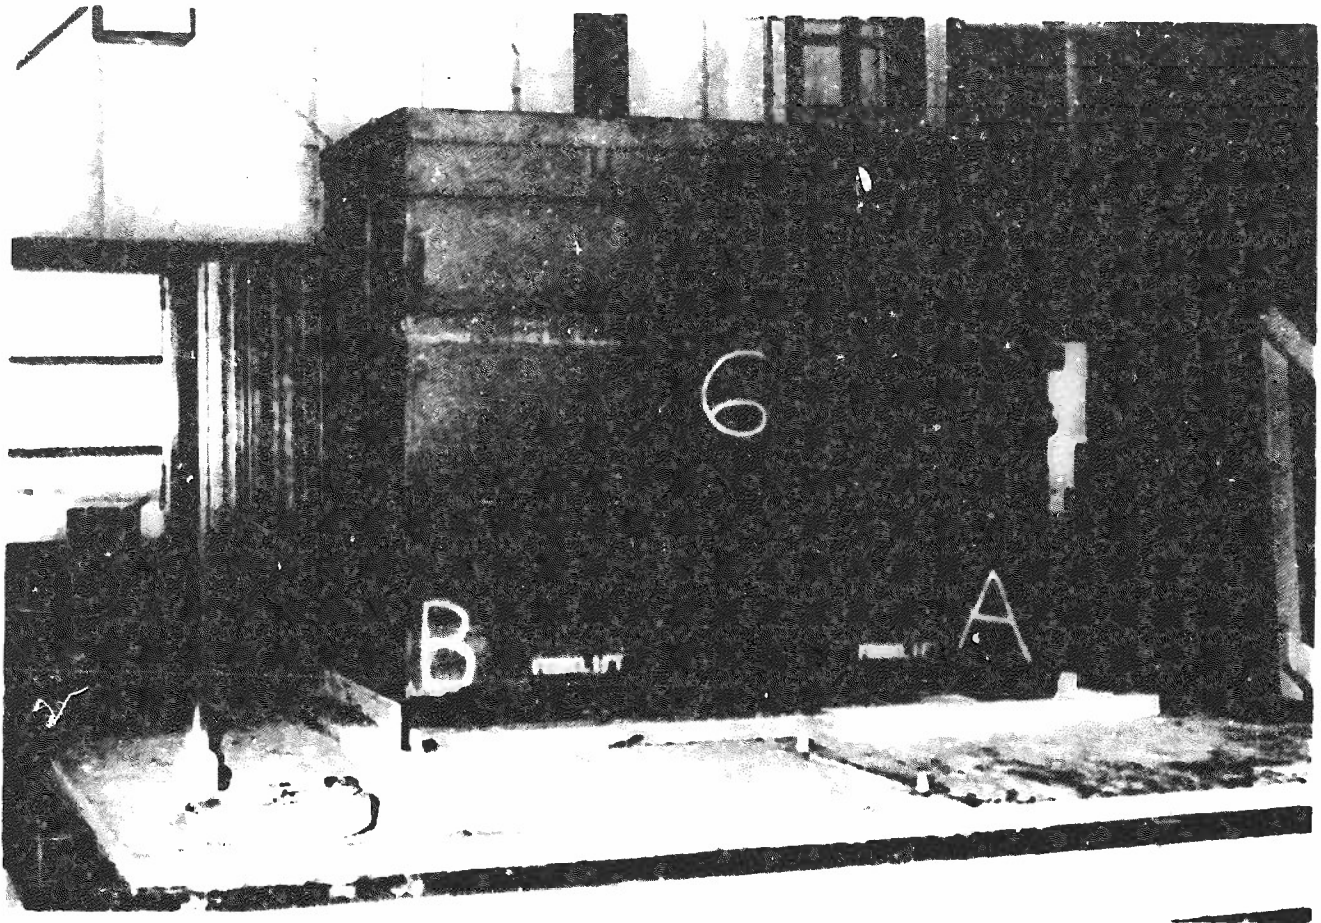
Comments: Although the vibration test was performed according to criteria listed in the test method, the attachment welds of the fork pocket to the container body were subjected to extremely severe loading forces which were excessive and not representative of the intent of the test. These excessive loads were generated primarily by the side to side rocking of the containers. However, since the containers were restrained at the bottom by a 2x4 fence (see Figure 8) and at the top by loose chains which prevented the containers from falling over and the input from the table was 1G, the test was completed.

FIGURE 8. Restraining system used for first vibration test. Chains (not shown) were also used to prevent container from falling over during the test.

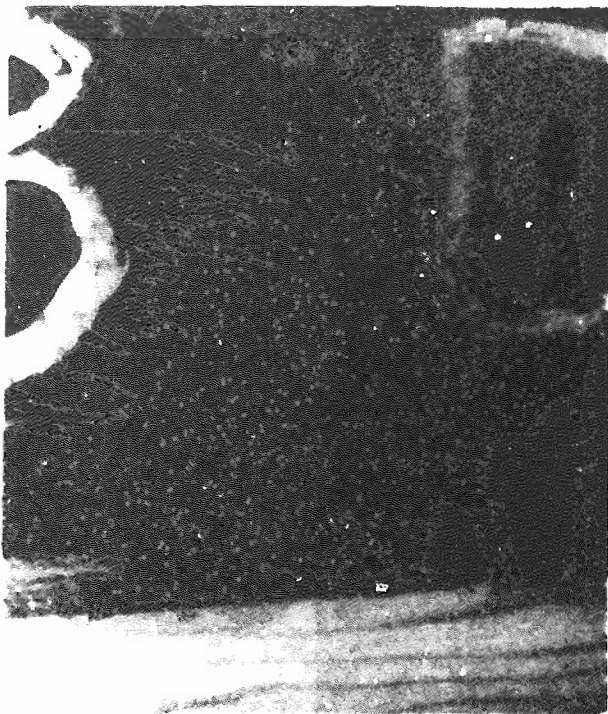
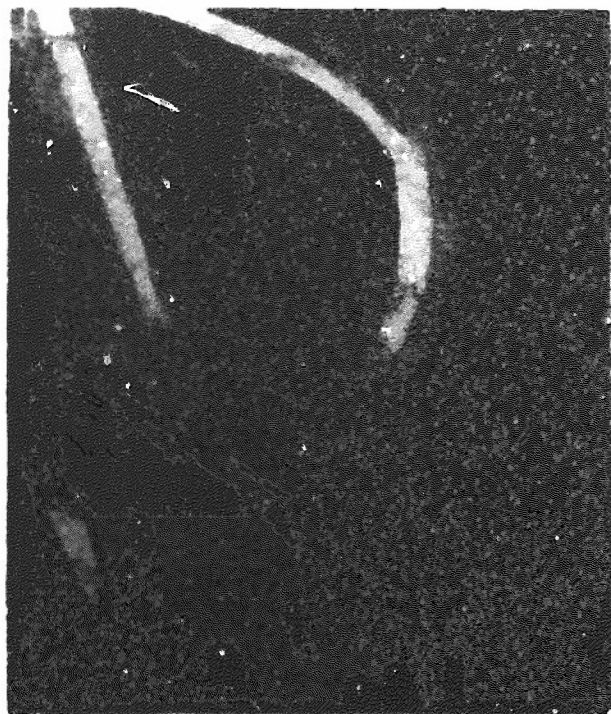
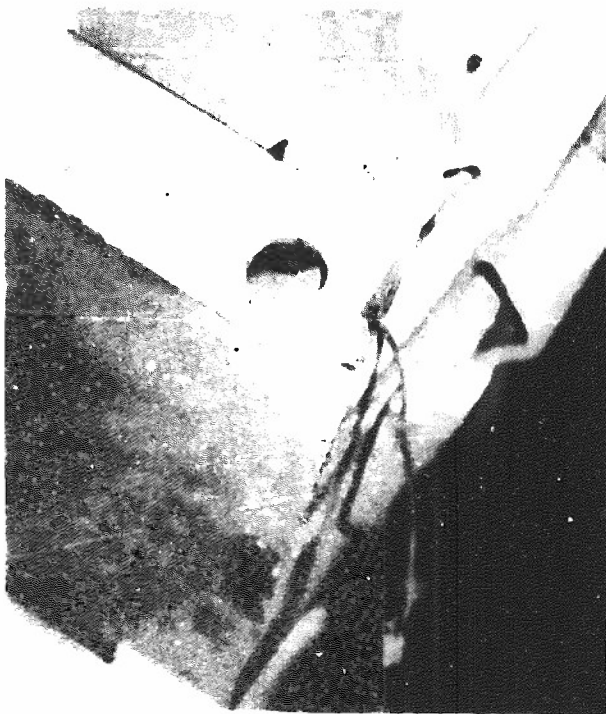
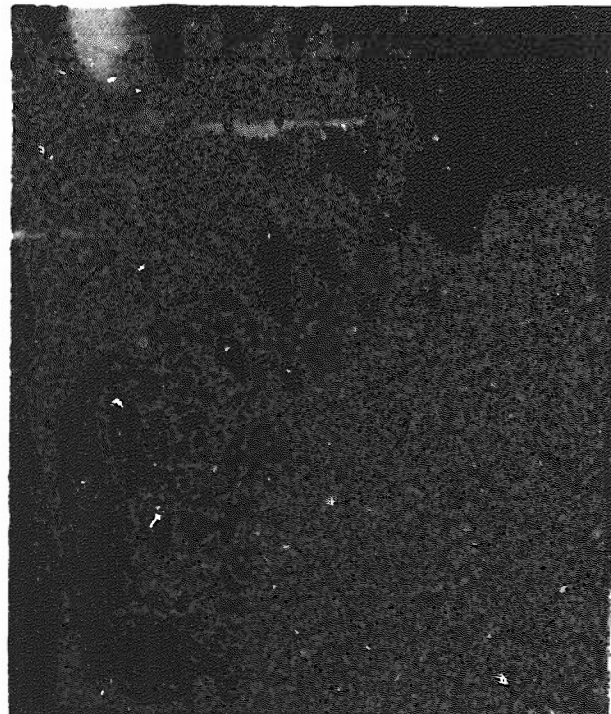
The end result was failure of the container skin material adjacent to the welds holding the fork pockets onto the containers (see Figures 9 & 10). Excessive wear to the pins and locking angles also occurred (see Figures 11 & 12). It should be noted that, after this vibration test was completed, a method providing a better restraining system that eliminated the rocking motion of the containers was developed. This method of further restraining the containers during testing was acceptable to all concerned (see Figure 13).

FIGURES 9, 10, 11 & 12. Damage to the containers during the first vibration test resulting in failure.

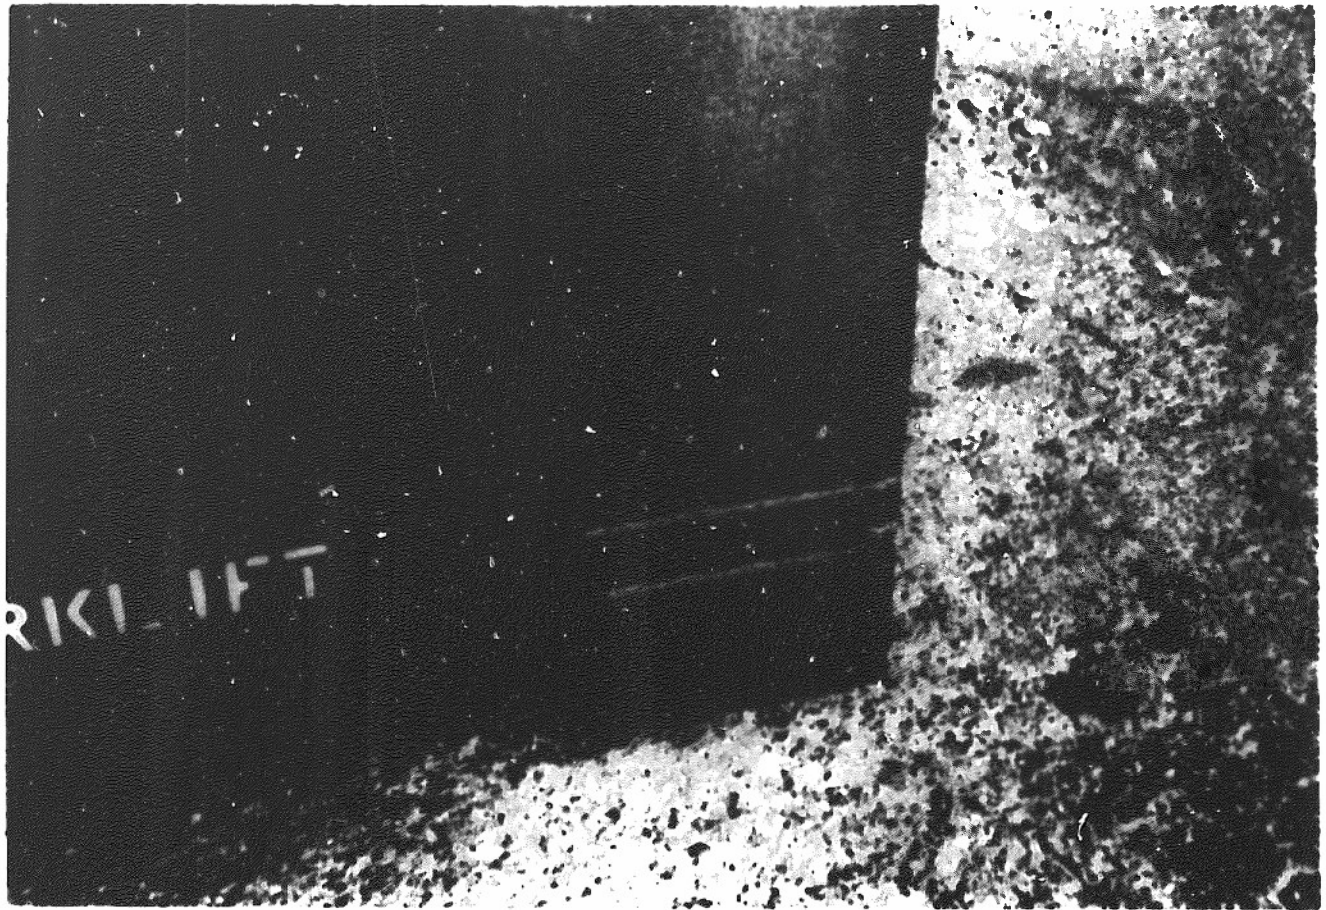
Preparations were made to load and use two of the remaining four containers and restart the testing sequence. The manufacturer's representative objected strongly to this approach, stating concern that the first modification which involved removing, changing, and then reattaching the forkwells had embrittled the container skin material during the second welding operation. Lanson offered to supply two new containers at no cost. This proposal was accepted. The two new modified containers arrived on Monday morning, 24 Jan 83. The modification consisted of welding the forkwell to these in angles (see Figure 14). These two containers, labeled TEST 1 and TEST 2, were loaded and prepared for testing. The test plan was altered from that previously used in two ways. Several of the tests were not repeated due to the results obtained in earlier testing. Also, the sequence was changed to reduce the significance of deformation from drop testing on the vibration test.

FIGURE 14. Modification used to prevent embrittlement of skin material from welding at point of forkwell attachment.

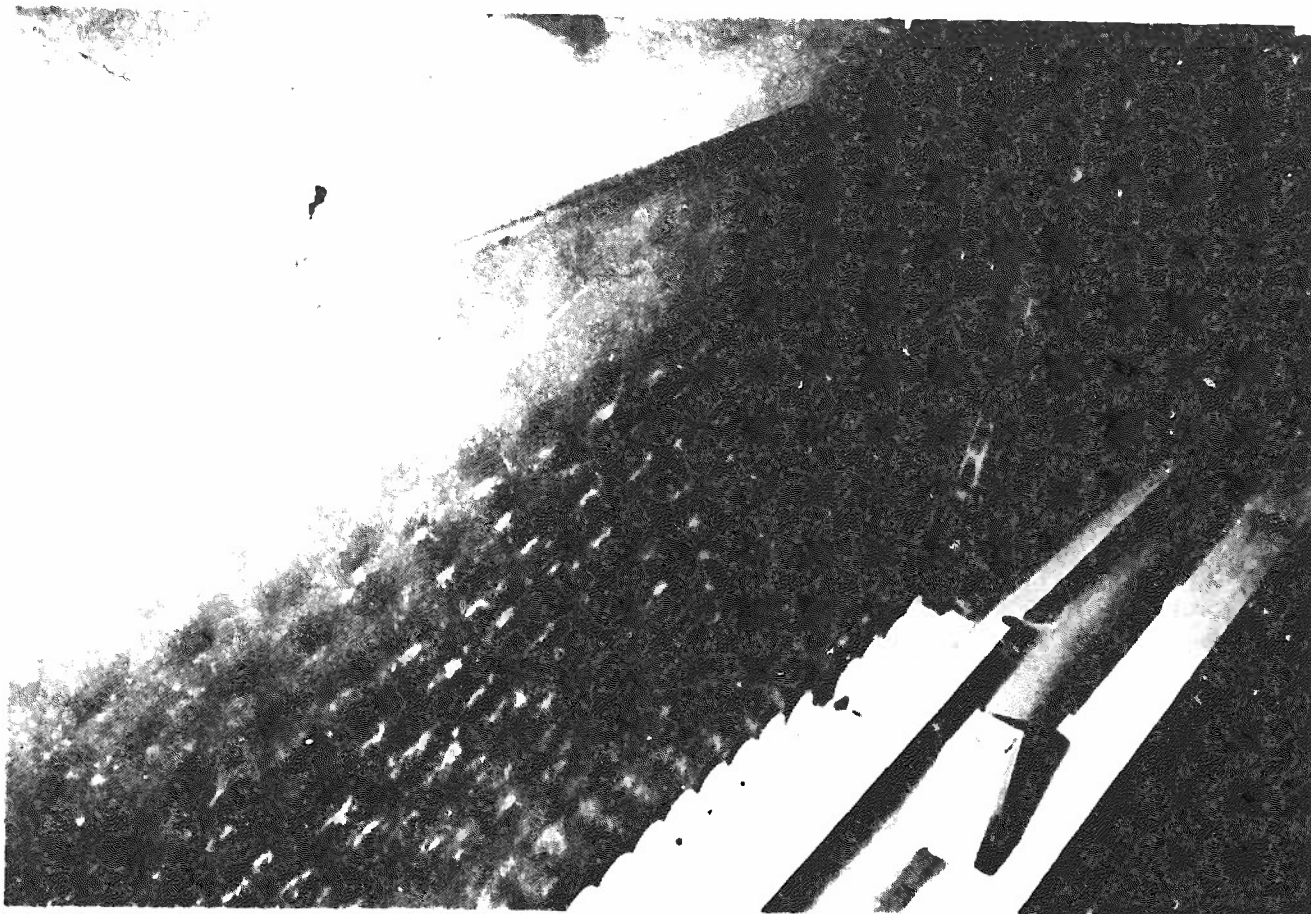
Following the final leak test, the containers were downloaded and the interiors inspected. With the exception of a narrow strip on the bottom of each container adjacent to the Mylar-coated side, no appreciable damage was noted (see Figure 15).

FIGURE 15. Minor scuffing to Mylar-coating inside container from vibration testing.

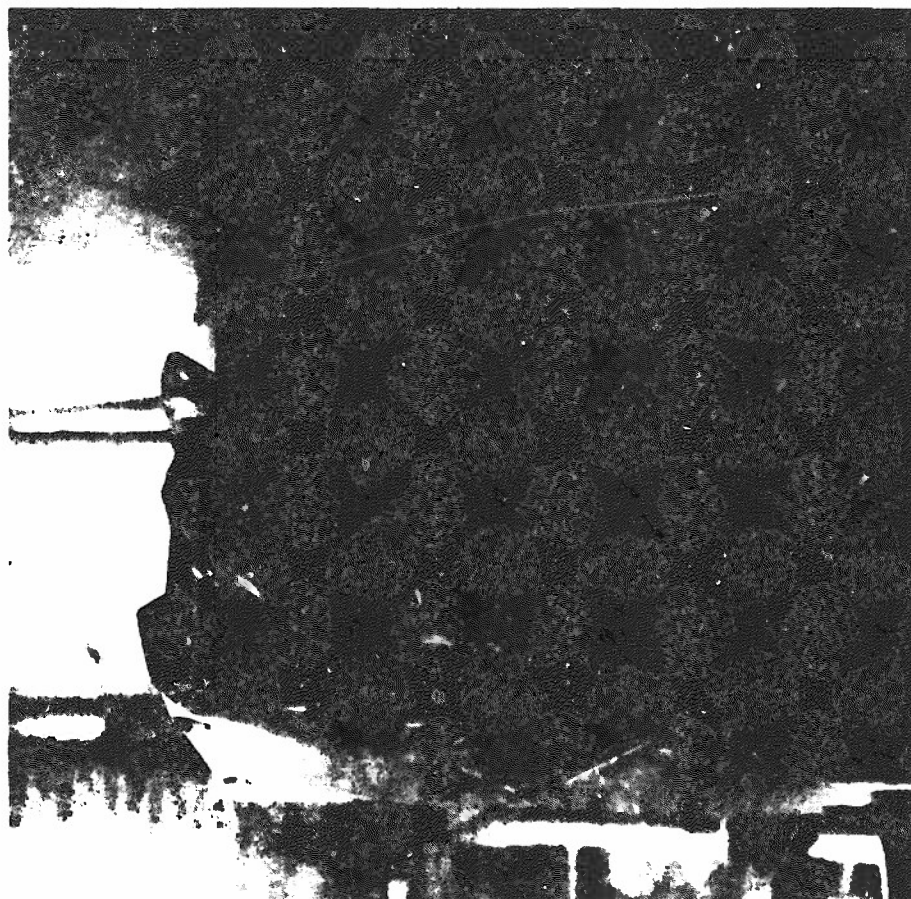
In view of the added cost associated with the modifications found on these new test containers, two of the original six containers, SN00001 and SN00002, previously untested were loaded. Only one test was conducted to determine the adequacy of the fork pockets. This was the modified version (rocking restraints) of FTMS 101, Method 5019.1, Vibration (Repetitive Shock) Test. The test was conducted on containers 00001 and 00002 exactly as it was for the two previous containers, TEST 1 and TEST 2. These containers also passed the vibration test with no damage. Environmental testing began on 25 Feb 83 with Method 507.1, Humidity; Ammunition and Natural Environment Cycles. In addition to the three-spot humidity indicators present on the containers, two three-spot humidity indicator cards, two irreversible humidity indicator disks, and three clean mild steel coupons were placed in the top of each container (see Figure 16). The lids were replaced and the containers sealed and placed into the humidity test chamber. The chamber malfunctioned on 27 Feb 83. The test unit was removed and the chamber was repaired. Again the containers were dried, sealed, and placed into the test chamber. The test was restarted on 2 Mar 83. The final tests were conducted on 23 Mar 83 and consisted of Method 506.1, Procedure I, Rain of MIL-STD-810C and the four-foot free-fall drop on the most vulnerable area (top corner) in accordance with 49 CFR. The test unit passed both tests. The results of the four-foot drop are represented in Figures 17 & 18.

FIGURES 17 & 18. Damage to the containers from four foot free-fall-drop test IAW 49 CFR.

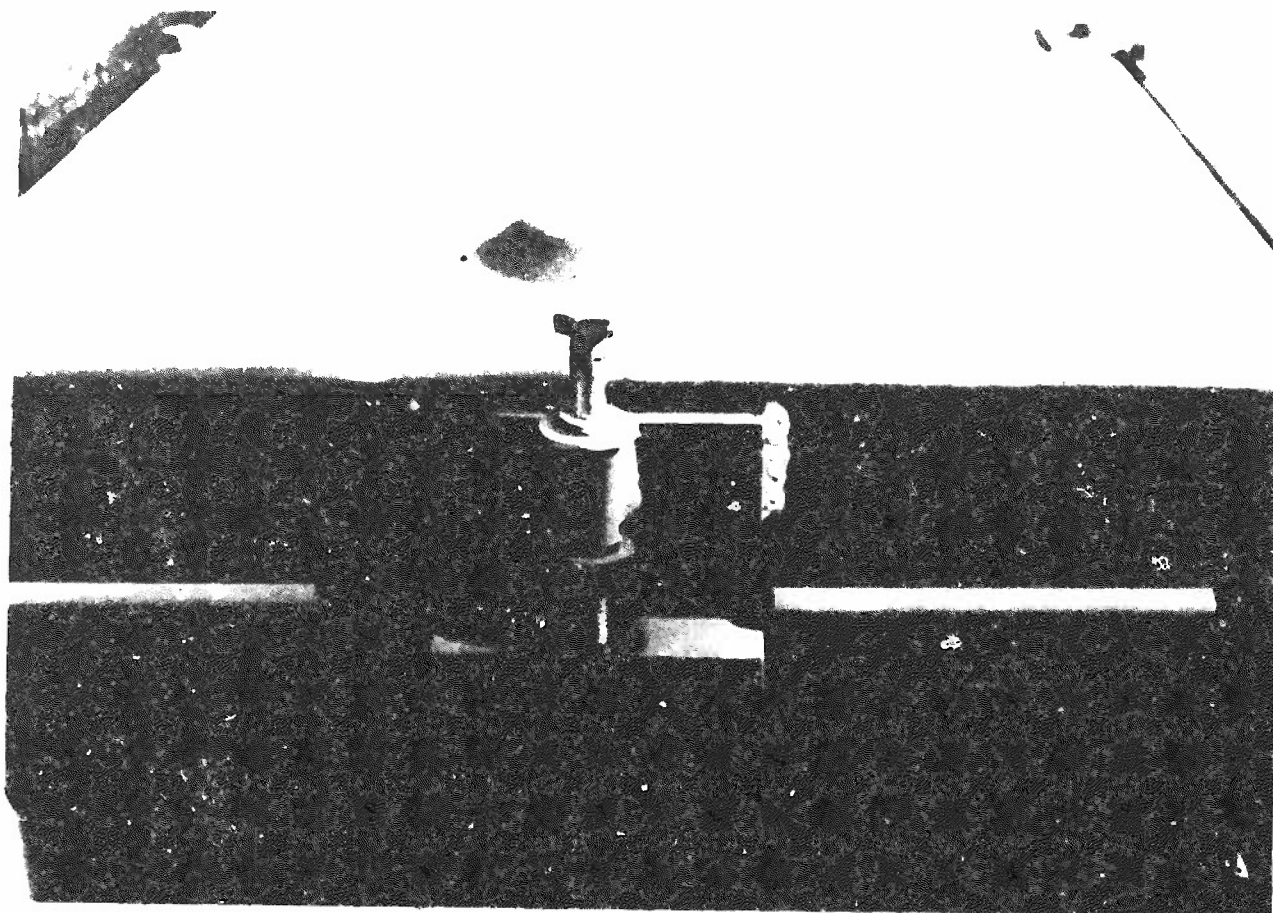
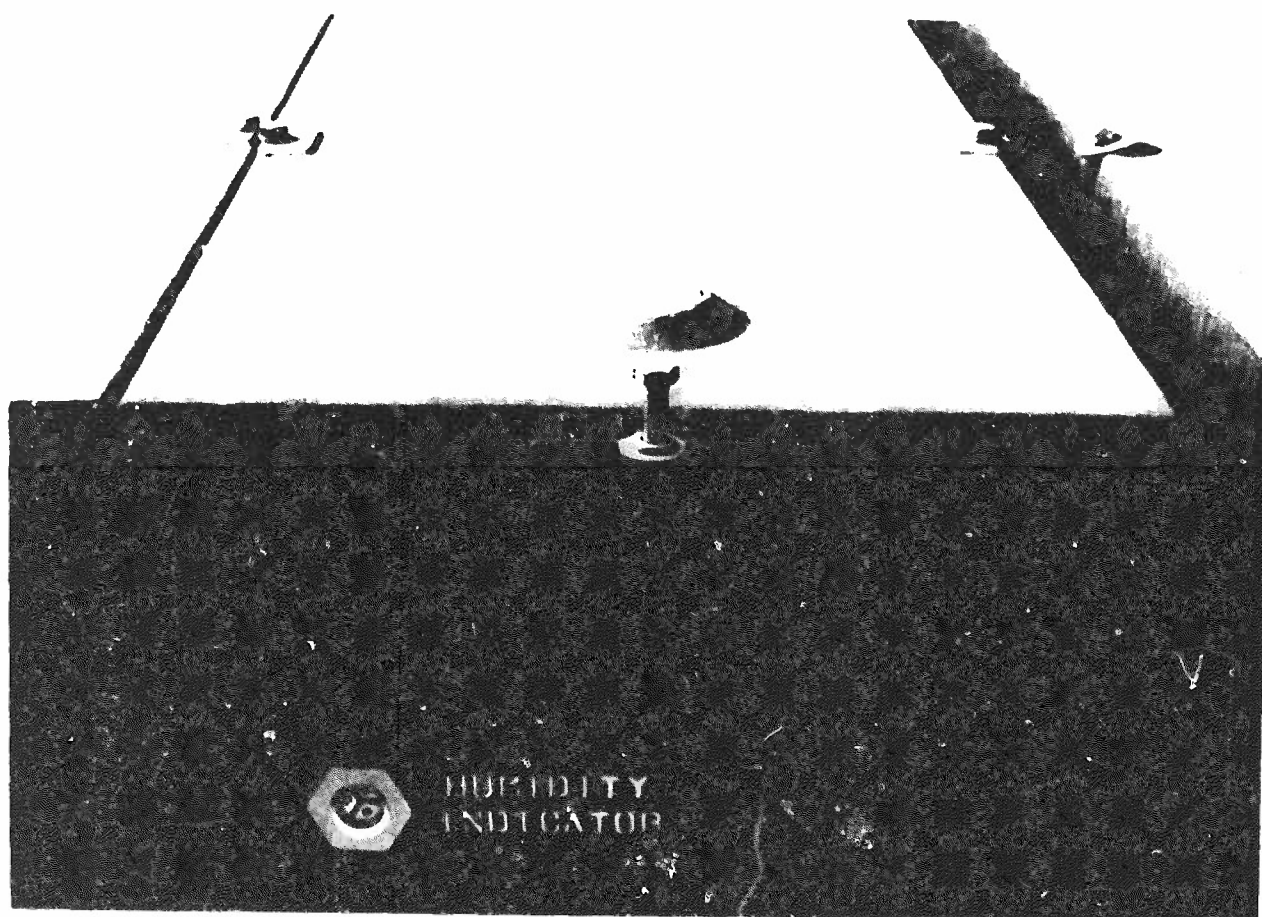
The most critical problem found concerns the width of the container lids. When two prototype containers are pinned together at the locking angles, their normal shipping and handling configuration, only one of the two lids can be correctly installed (see Figures 19 & 20). In order to install the second lid, the containers must be uncoupled and spread apart, a difficult operation since each container weighs approximately 1200 pounds.

FIGURES 19 & 20, Misaligned lid fasteners.

The width of the container lids should be reduced by the previously prescribed 1/4 inch to insure adequate clearance between containers. This change should definitely be incorporated into the design prior to delivery.

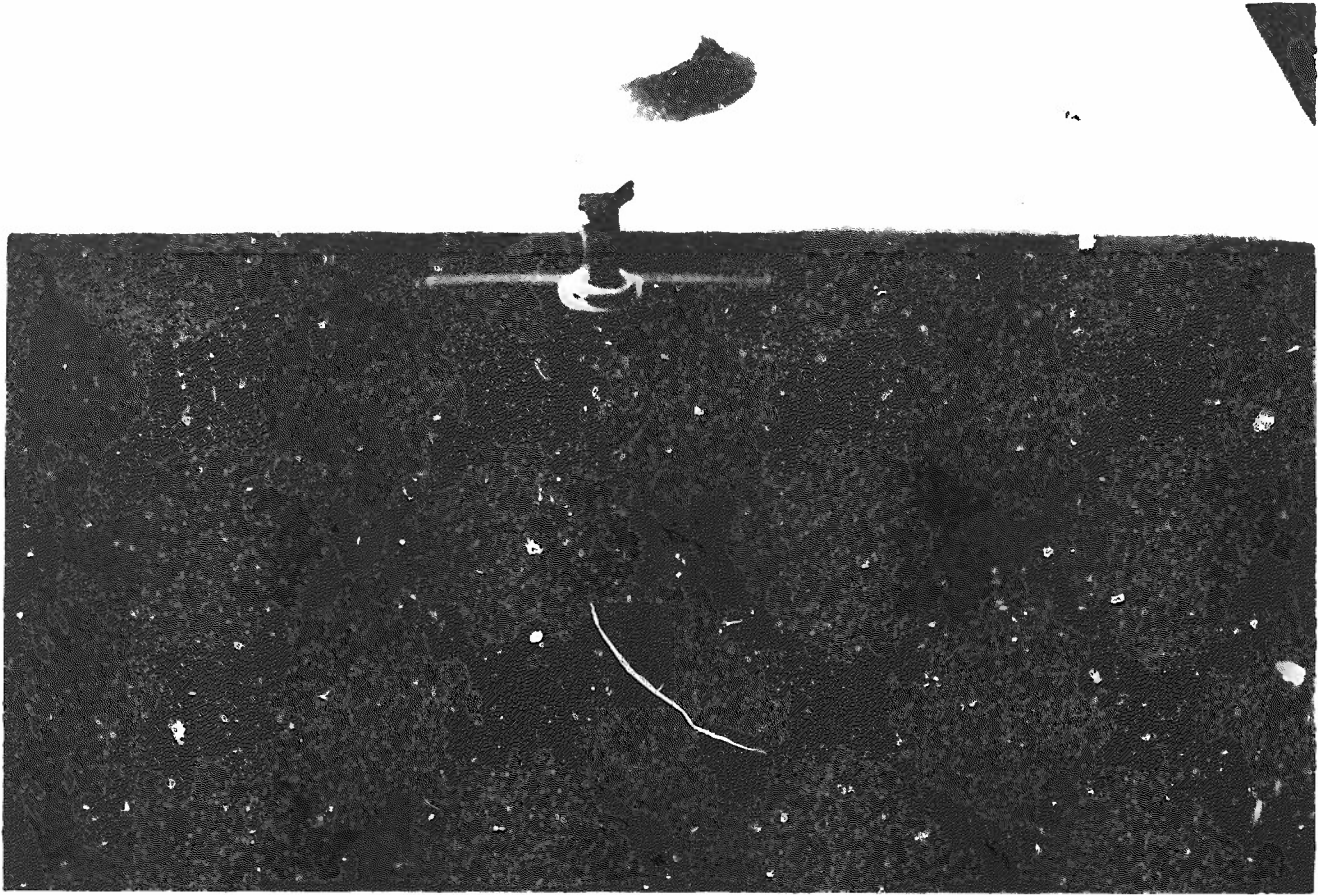
On 18 Apr 83, two additional containers were delivered to AFPEA. These containers incorporated modifications to correct the deficiencies previously identified. The problems with the desiccant port covers and the end fasteners on the lids were corrected. However, the problem with no clearance between the container lids when the containers were in their pinned configuration still existed. AFPEA had recommended a reduction in the container lid width of 1/4 inch. If this recommendation were followed, 1/16 inch to 1/8 inch clearance would exist between the container lids, allowing ease of operation. OO-ALC decided that a lid width reduction of 1/16 inch was all that was needed to provide the necessary clearance between the lids and would result in a "worst case" of a line to line fit. The two additional containers with the 1/16 inch lid width reduction are shown in Figures 21 & 22. As can be seen, negative clearance exists. The negative clearance is evident by the wear spots in the paint and metal where the lids touch and by the misalignment of the end fastener on one lid.

FIGURE 22. Misalignment of end bolt lid fastener on latest version of container received indicating no clearance between containers. Note the steel gussets welded to threaded bar and container side wall to reduce effect of bending moment on end bolt fasteners.
